Inspection report - Baku Metro November 2015

2. Description & Project History

5. Control of the Dry Film Thickness (DFT)

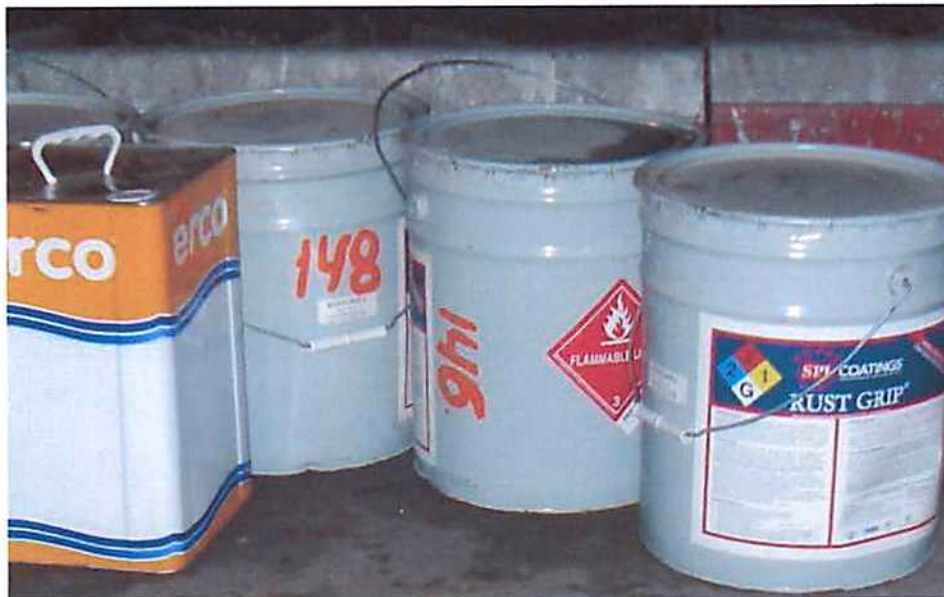
The staff, who is in charge of the coating application at the Metro, is very well aware of the absolute must of a dry and clean substrate prior to apply Rust Grip®. They are very conscious about this and act very consistently. For example, wet or greasy parts have been not treated. Also very detailed notes and reports have been made every single night, indicating in which section the application has been performed, when they have started working on the 1st and 2nd layer application, when they have finished, who has done the application, how many m² have been treated and which nr. of Rust Grip® pail has been used, as well as each pail has been numbered.

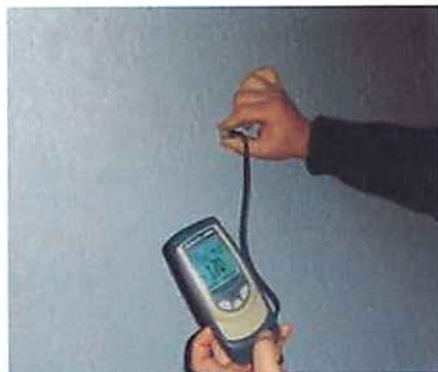
170 μ

Below some DFT measurements, taken on the most flat possible areas after calibration by use of plastic shim (calibrated at 255 micron), are shown.

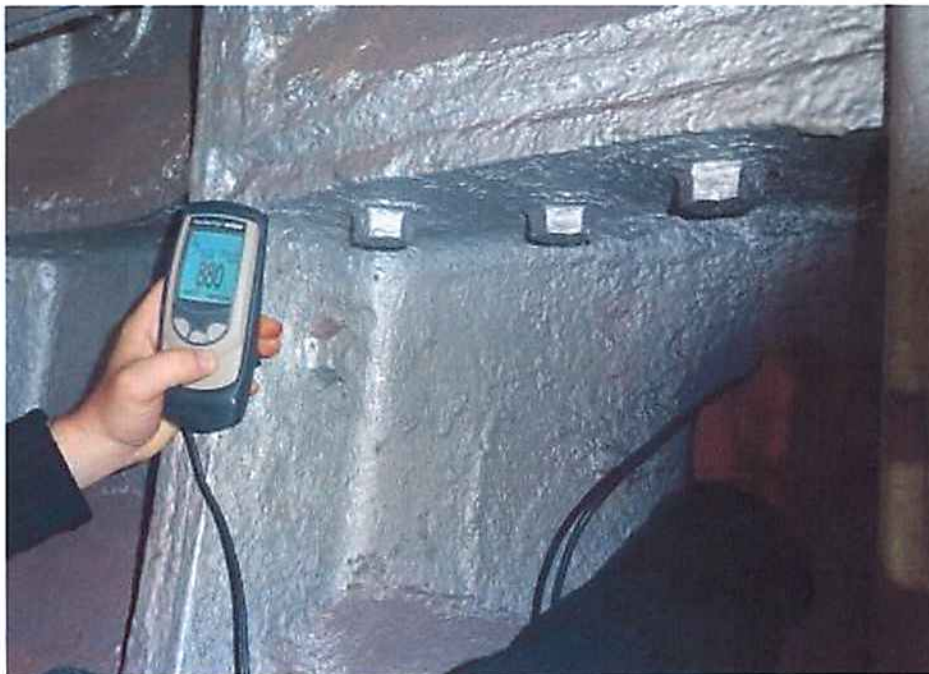
880 μ

It must be noted that, due to the very rough surface profile, in most areas it was impossible to find a smooth surface to make appropriate measurement by using a Delfesko PosiTector 6000 with Type 2 gauge.

This translates into much higher thickness measurements, as shown below.

I can confirm that, during my visit, I have not seen 1 single check point having less than 150 μ DFT and never spotted an area showing corroded pin holes.

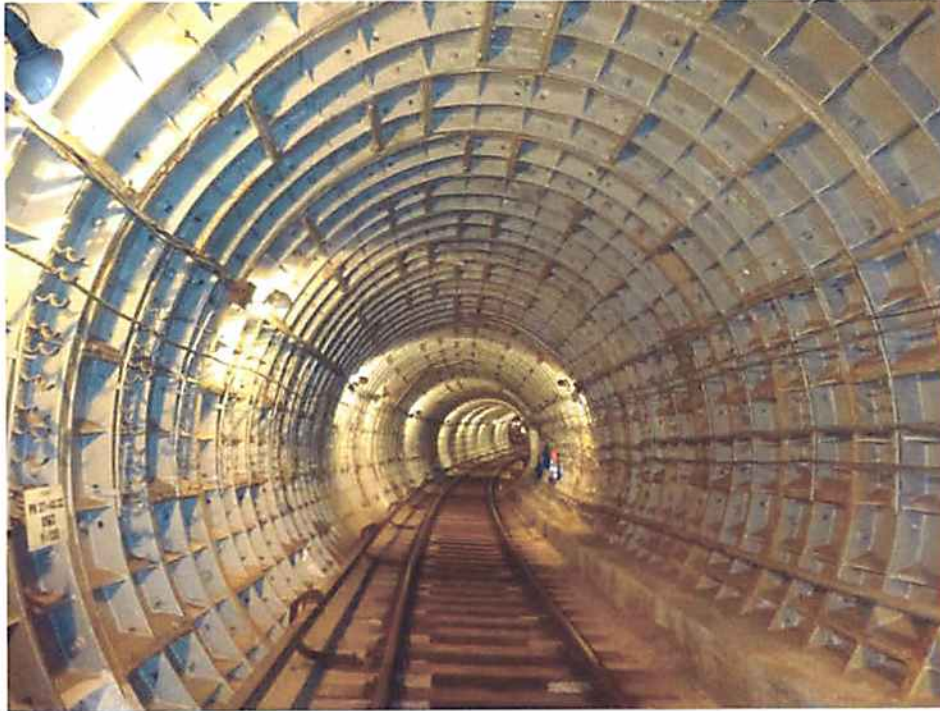
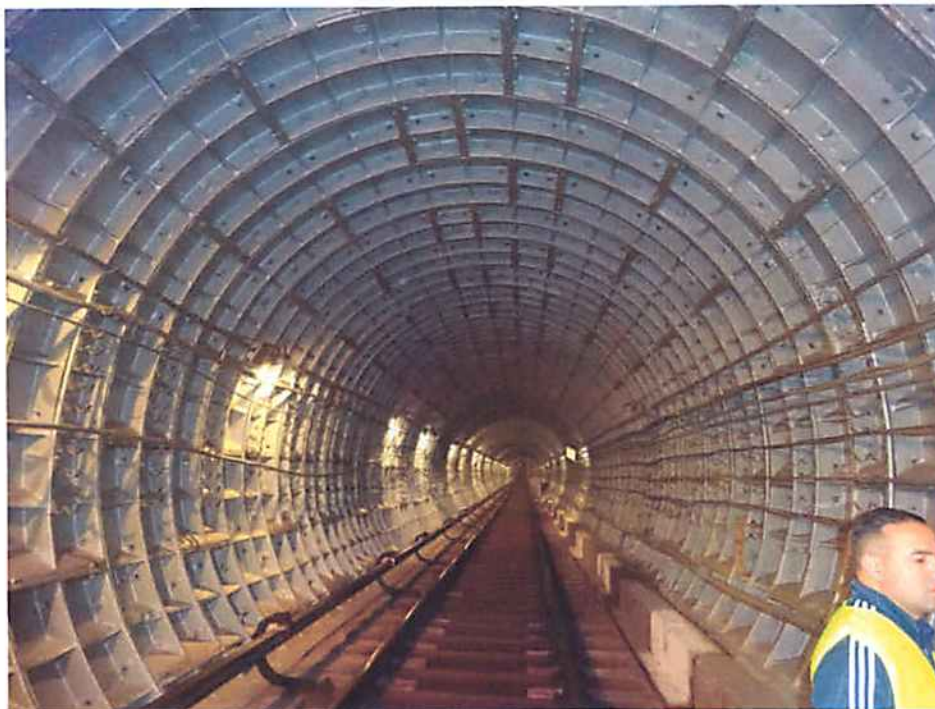
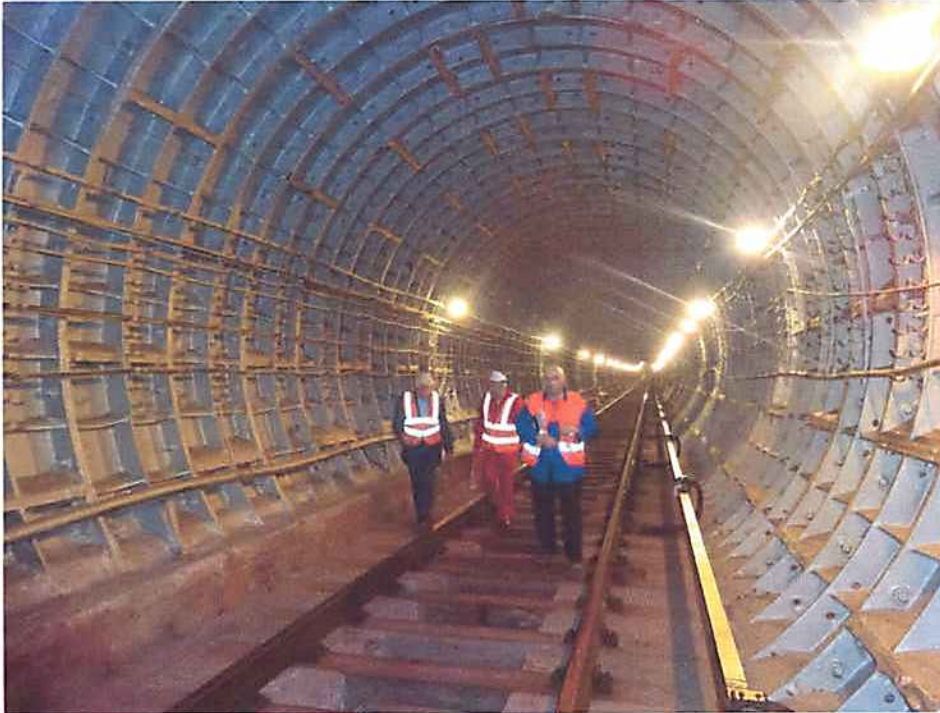
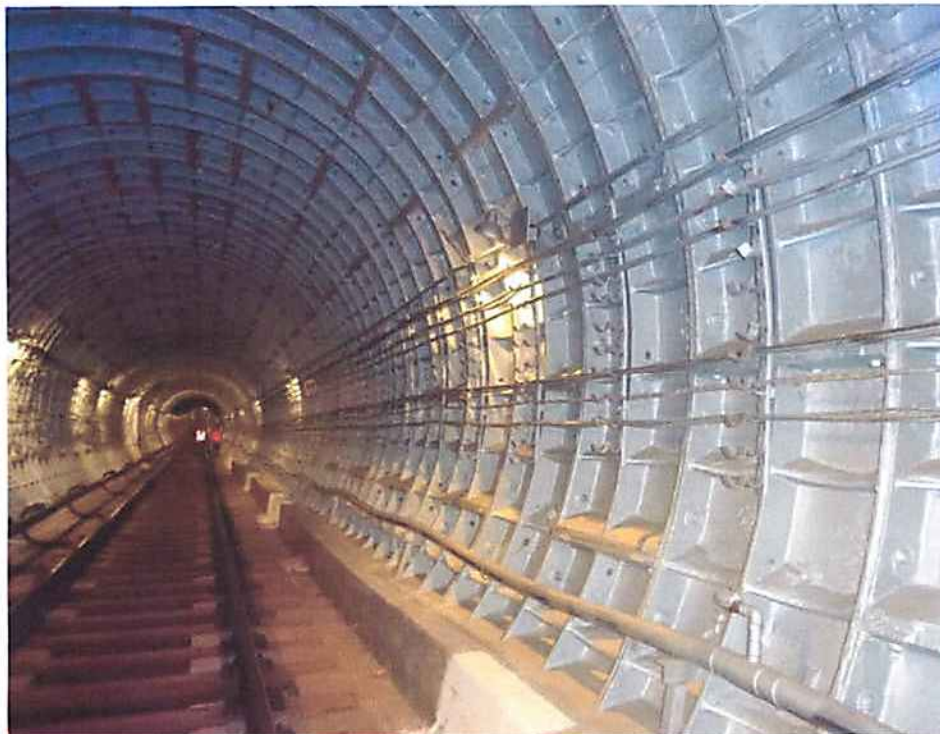
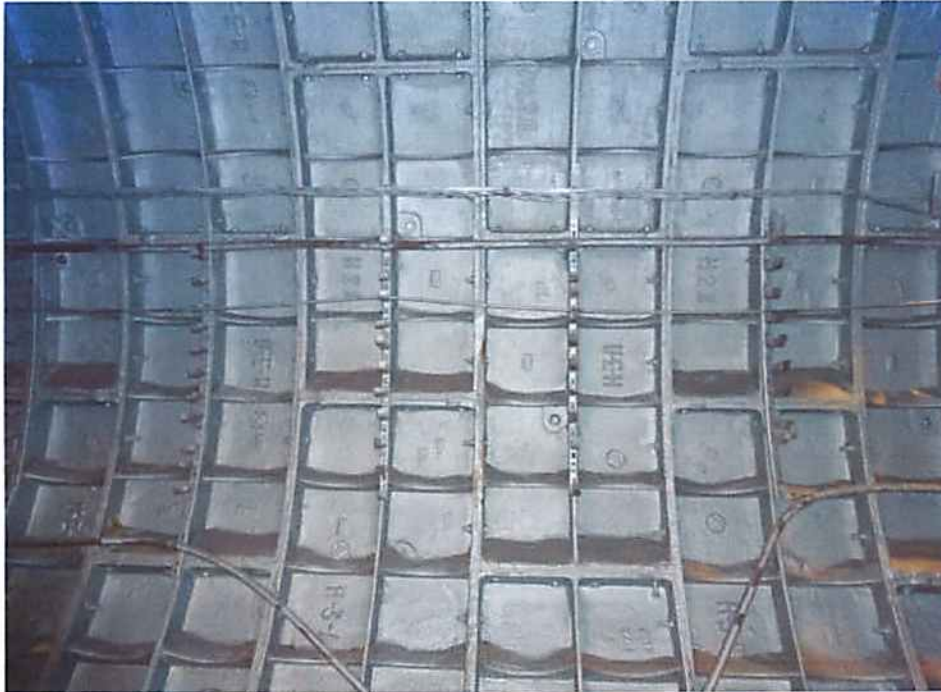
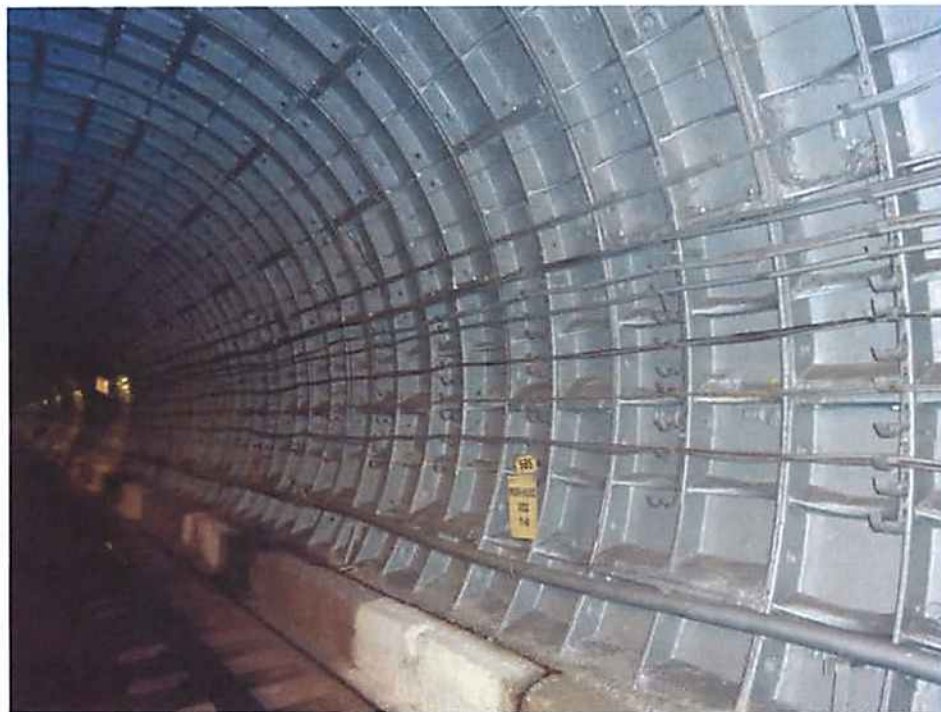
On next page you find some images after completion of different Metro sections.
