# **SUPERIOR PRODUCTS INTERNATIONAL II, INC.**

## **ATR TRANSPORTATION - BUSES IN FORLI, ITALY**

### **Testing of Super Therm<sup>®</sup>**

**Statuto Service S.r.l., Milan, Italy**

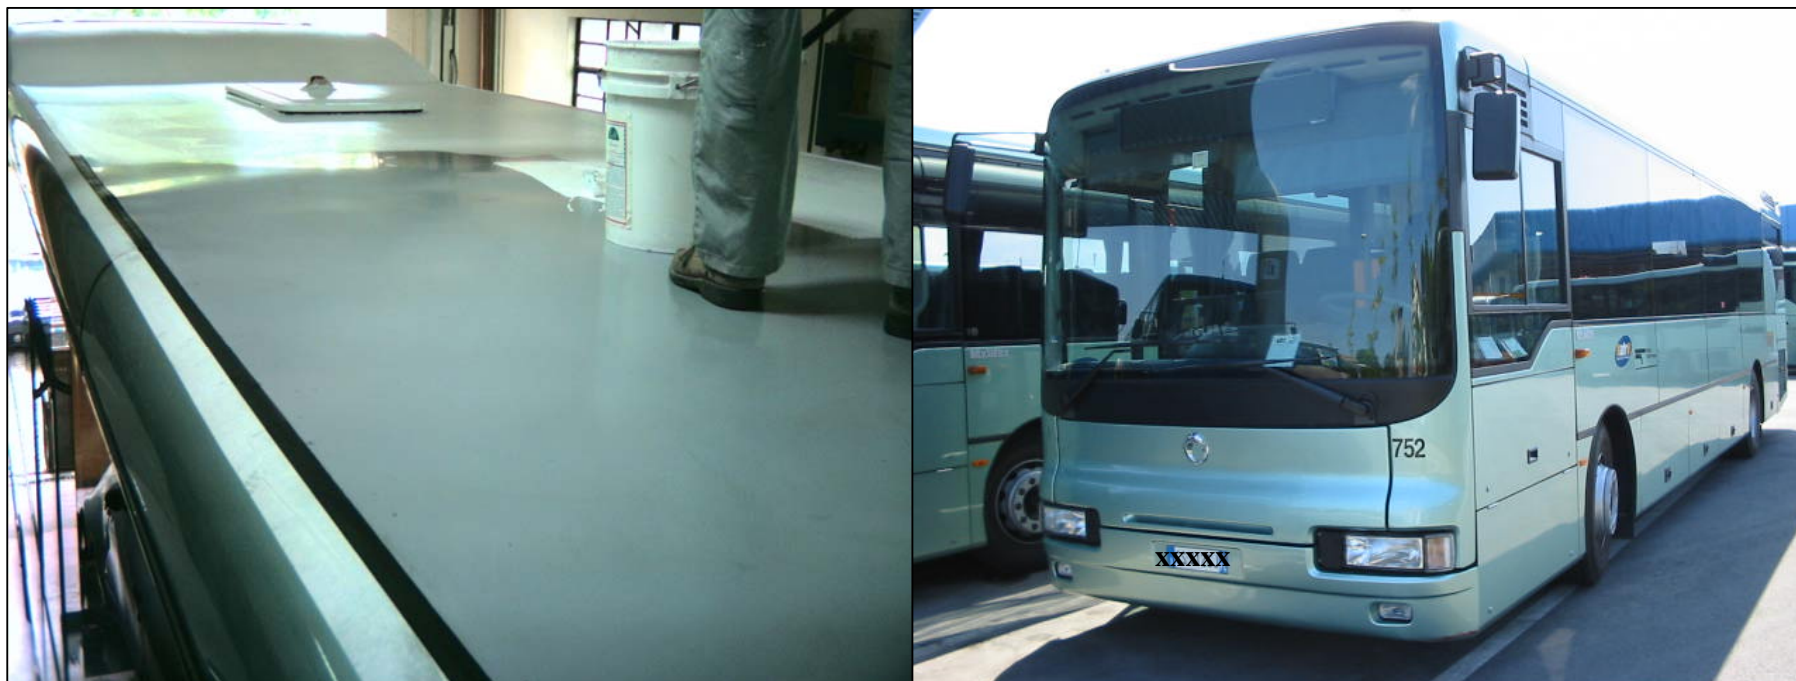
*Foto 1 - 2*  
*Applicazione Super Therm ed Enamo Grip sul tetto di un autobus.*

Super Therm<sup>®</sup> can be applied by any reputable paint shop where standard painting work is performed.

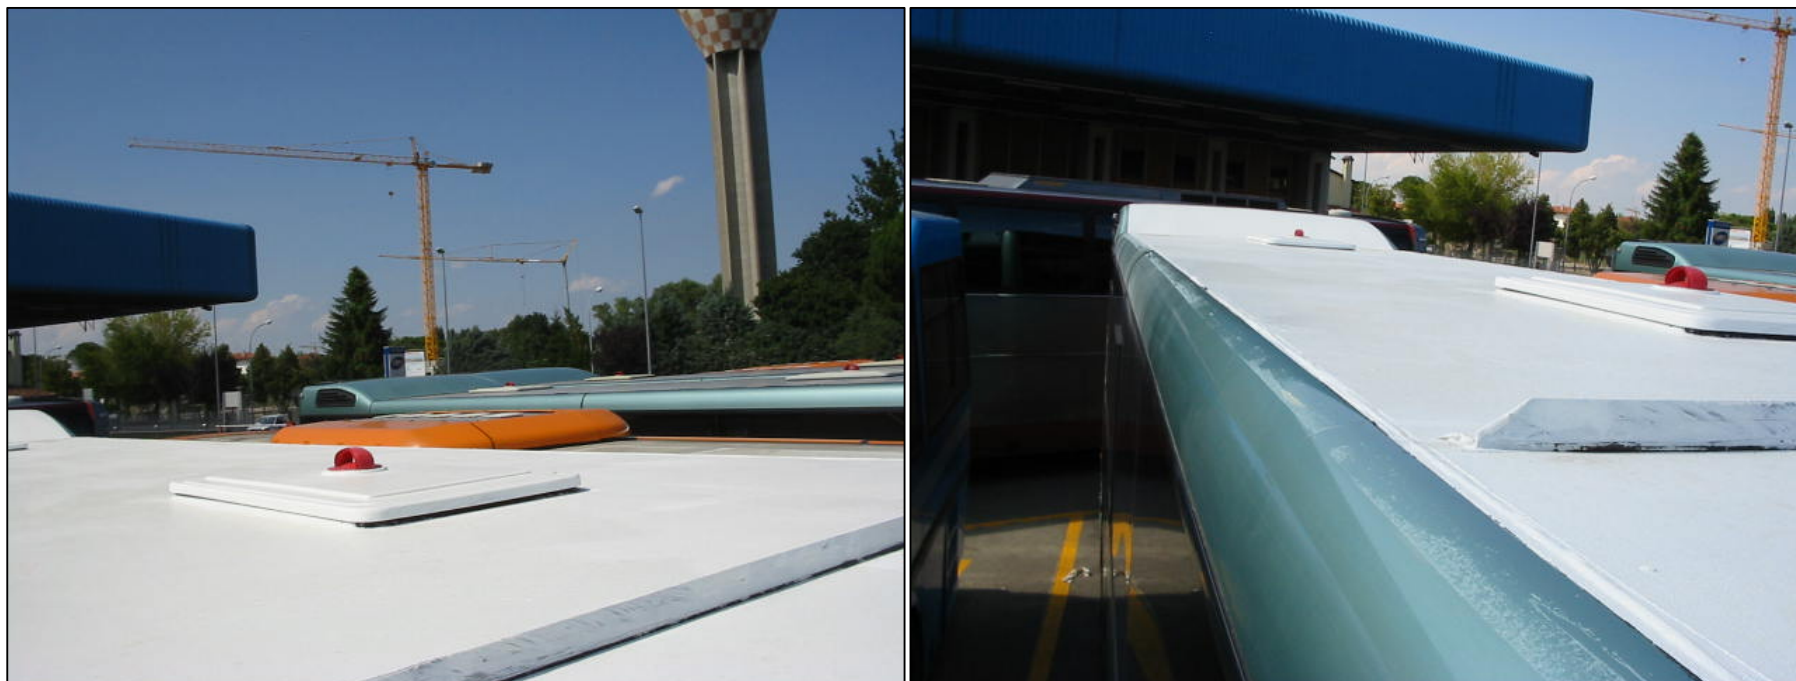
*Foto 3 – 4*  
*Autobus (trattati e non) disposti nel piazzale per la rilevazione della temperatura interna.*
