**Super Therm® Test Study  
Passenger Bus Roof Application  
City of Hermosillo, Sonora, México.  
June 2005**

**Test Study: Results of the Application of Super Therm® on Passenger Bus.  
Company : Econotours, Hermosillo, Sonora, México.**

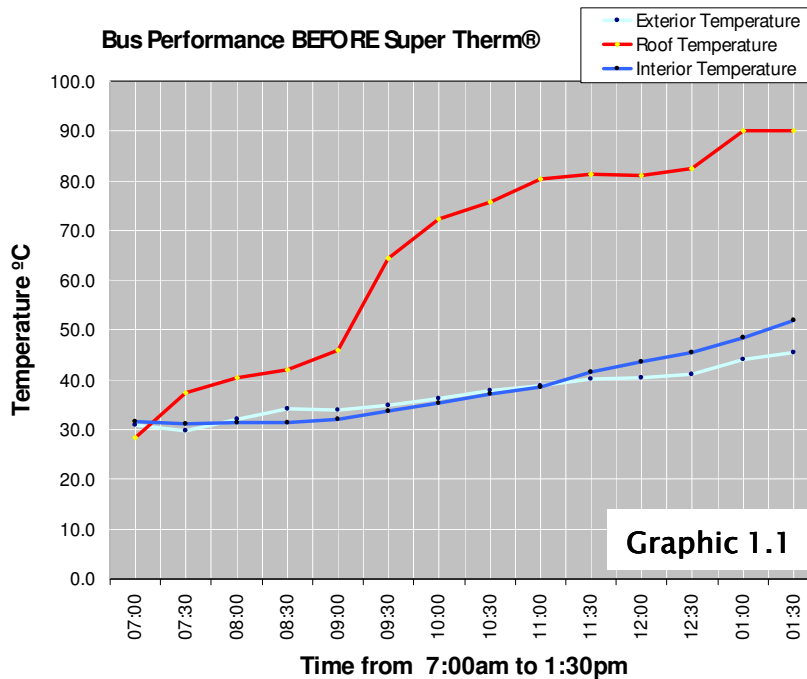
**Graphic 1.1**

Friday, June 24, the bus remained completely closed from 7:00am until 1:30pm, this with the intention of registering the inside and roof temperatures every 30 minutes, Table 1.1 and Graphic 1.1.

We can see that temperature increased from 28.4 °C to 90.1 °C from 7:00am until 1:30pm. A range of 61.7 °C, 9.5°C each hour.

The temperature rose at a faster pace from 9:00am till 11:00am, from 45.9 °C to 80.4 °C, it increased 34.5 °C in only 2 hours. This is a total of 17.2 °C rise each hour.

The inside bus temperature from 7:00am till 1:30pm went from 31.7 °C to 52.0 °C in a lapse of six and half hours. The temperature rose 20.3 °C. At a pace of 3.1 °C each hour. Also we can see the inside bus temperature rose gradually from 31.7 °C until it reached 52.0 °C at 1:00pm.

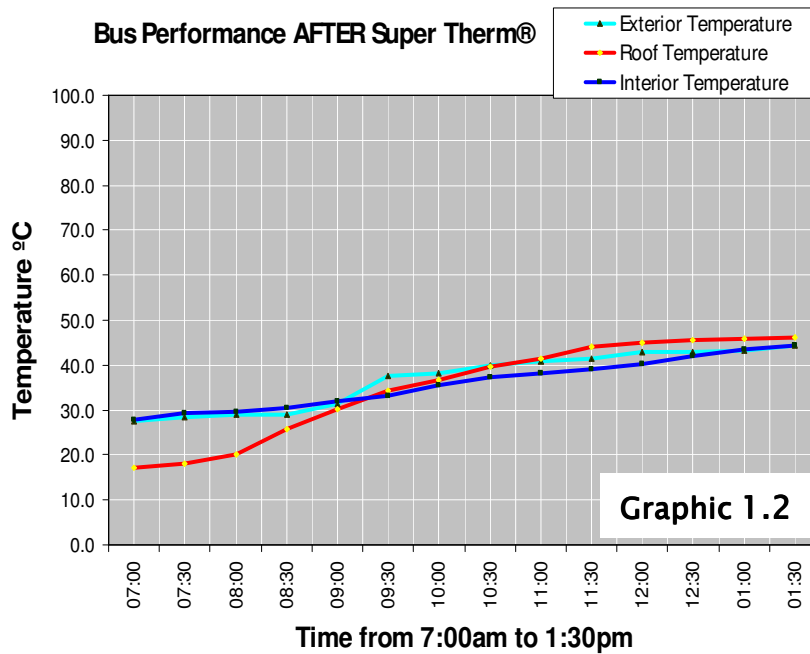
Saturday, June 25, 2005.  
Table 1.2 and Graphic 1.2

We can see in the table 1.2 and graphic 1.2 that at 7:00am the roof temperature was 17.2 °C, while at 1:30pm the recording was of 46.2 °C. The temperature increased 29.0 °C in 6 and half hours, this average 4.46 °C rise each hour.

In this period of time the highest increment on the roof's surface was from 8:00am to 11:30am (from 20 °C till 44.1 °C). In a period of 3 and half hours the temperature increased 24.1 °C. After 11:30am the roof's surface temperature remained almost constant with a value of 46 °C (see graphic 1.2).

In the table 1.2 and graphic 1.2 we can observe the temperature record inside the bus, at 7:00am, was 27.8 °C and at 1:30pm the temperature was 44.5 °C. The temperature inside the bus increased, in a lapse of six and half hours, 16.7 °C. Under these new circumstances we can observe the inside temperature and the outside temperature performed similarly from the beginning of the test until the end. (Graphic 1.2) Also we can observe how the roof's temperature was below the outside temperature and inside temperature from 7am to 9am (17.2 °C to 30.1 °C); after 9am the temperature behavior on the roof was very close to the other two temperatures (outside and interior, see table 1.2 and graphic 1.2)

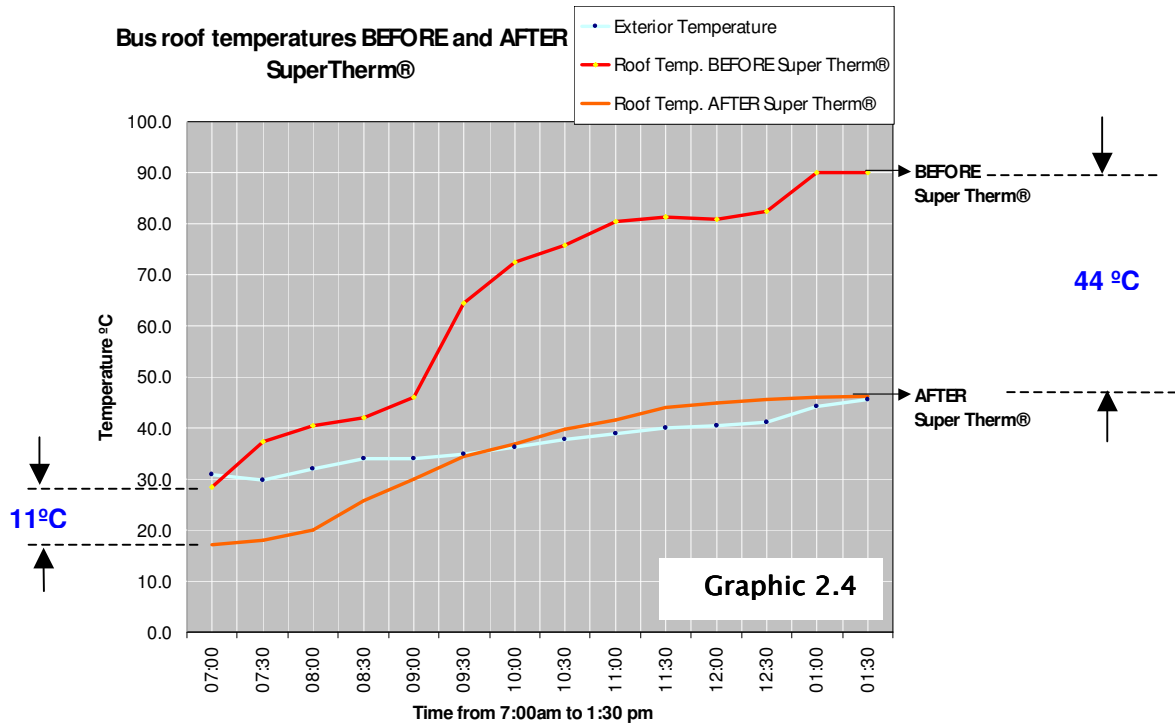
## Graphic Representation of Roof Temperatures Before and After SUPER THERM

In Graphic 2.4 we see the roof temperatures before and after applying SUPER THERM®. We can see the huge differences in temperature values from the time the test began until the end. At 7:00am SUPER THERM® had reduced the temperature by 11 °C, by 1:30pm SUPER THERM® had reduced the roof's temperature by 44 °C. The percentage of heat reduction during the test time was of **46.27 %**, close to half.

1. Before coating with SUPER THERM®, the roof's temperature and the interior temperature were much higher.
2. After application of Super Therm the roof's temperature was significantly lower than before application. Without Super Therm the roof's temperature rose to **90.1 °C**, after SUPER THERM the temperature only reached **46.2 °C**. This proves SUPER THERM's strength in reducing heat transfer (Refer to Graphic 2.4).

4. The Super Therm coated roof absorbed **46.27% less heat** than the non-coated roof (Refer to Graphic 2.4).
5. With Super Therm®, the Thermo King unit only needed 33.4 minutes to reach 29 ° C, **45 % less running** time than without using Super Therm®. (Refer to graphic 2.6).

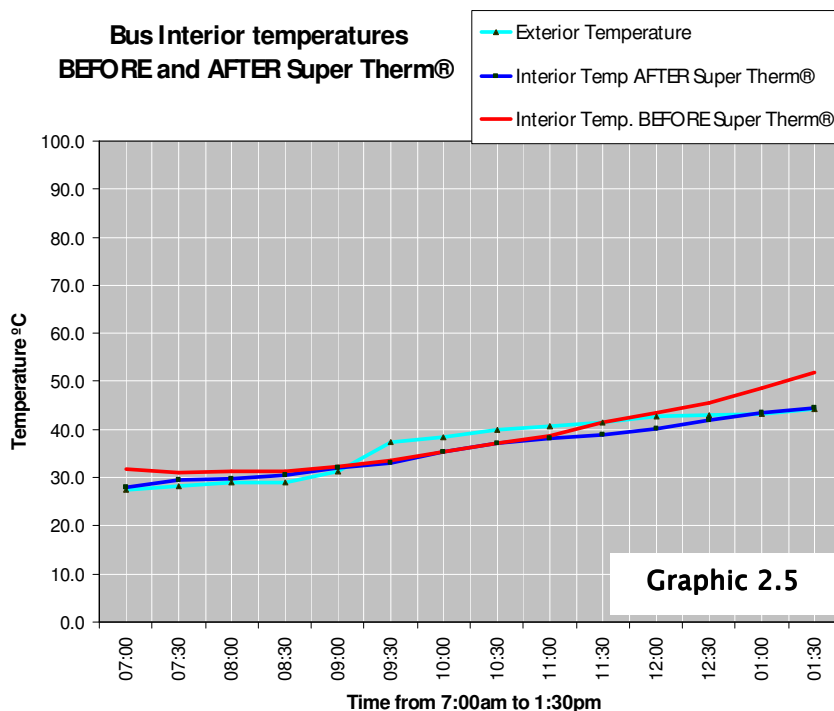
3. As a direct result of application of SUPER THERM®, the temperature inside the bus **decreased 8°C**, always tending to equalize itself with the outside temperature during the test (from 7 a.m. to 1:30 p.m.) (Refer to Graphic 2.5).

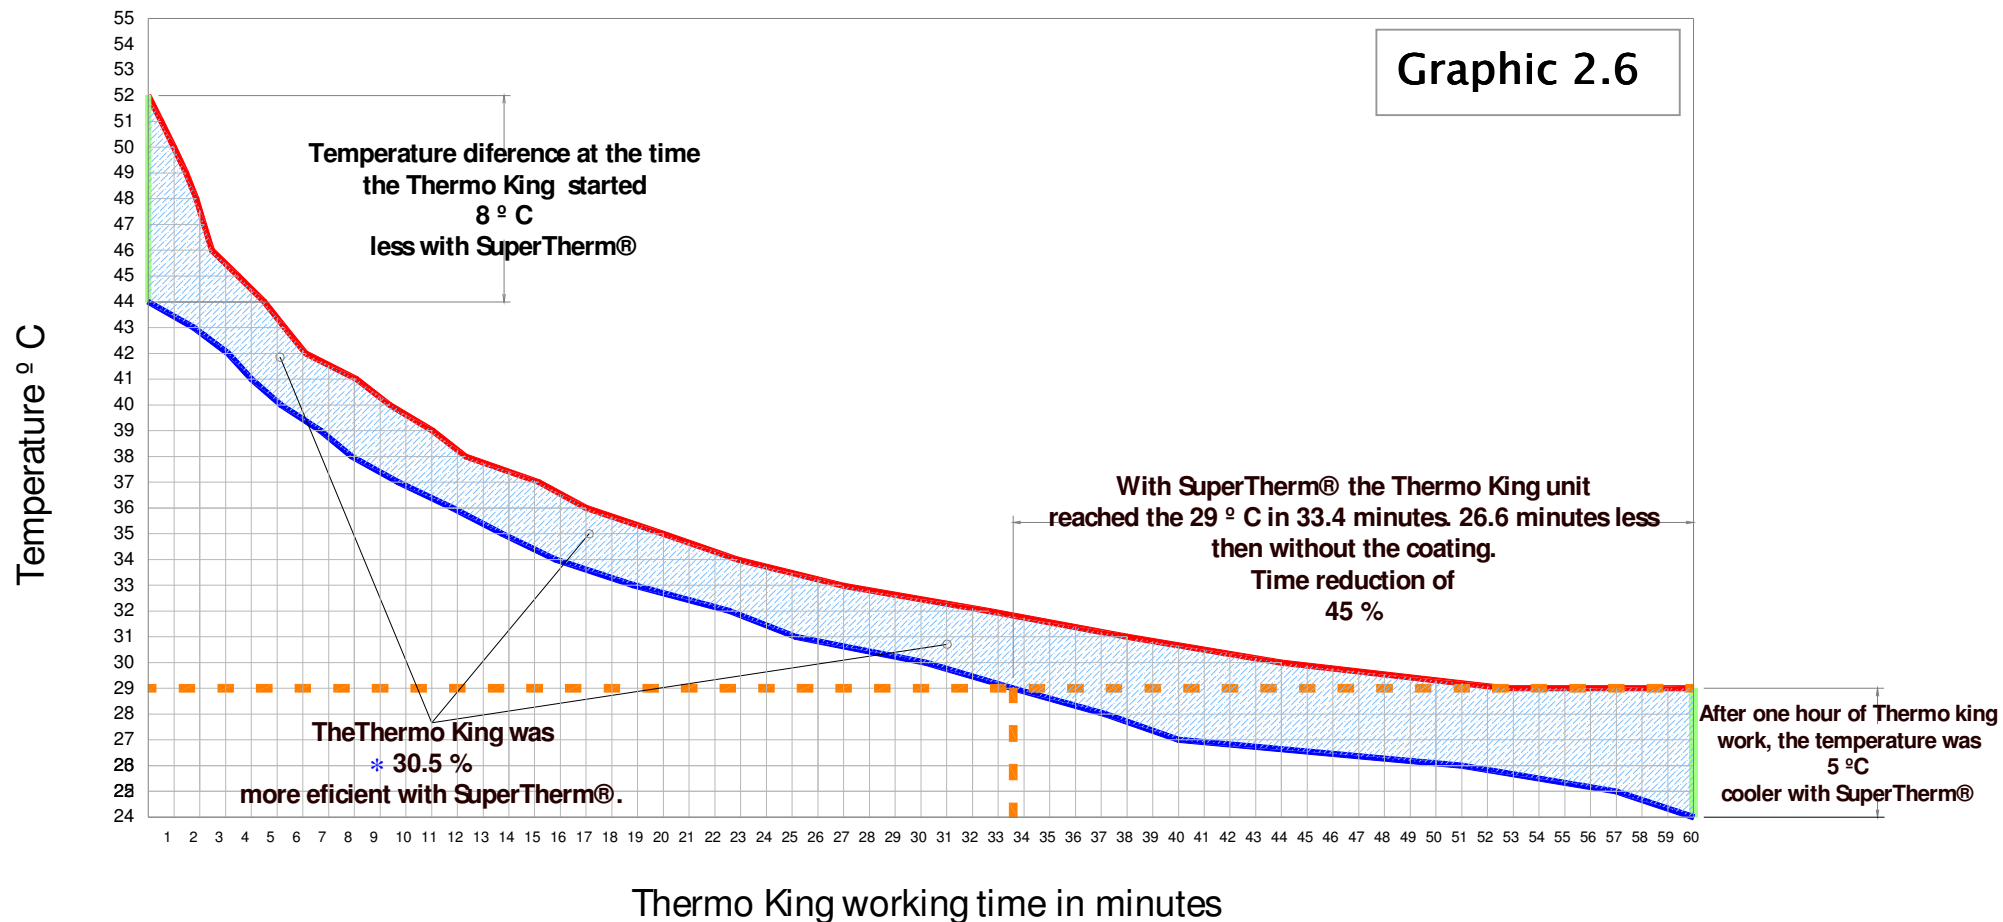
# Thermo King efficiency BEFORE and AFTER Super Therm® Application

— Bus interior temperature BEFORE SuperTherm®

— Bus interior temperature AFTER SuperTherm®

\* Outside temperature at 2:00 pm 46.5 ° C.  
at the time the Thermo King started running on 06/24/2005

\* Outside temperature at 2:00 pm 44.3 ° C.  
at the time the Thermo King started running on 06/25/2005

\* The 30.5 % efficiency is obtained by comparing areas. The first area which is represented by the graphic without Super Therm® (area formed by the x, y and red line) is taken as 100 %. The second area represented by the graphic with Super Therm® (area formed by the x, y and the blue line). This last area represents 69.5 % of the first area. The efficiency is represented by the blue hatch area and equals 30.5 %.

When the uncoated Thermo King unit was started the first day, at 2:00pm, the temperature inside the bus was **52 °C**. At that time the outside temperature was 45.6 °C and the roof's temperature was **90.1 °C**. After the Thermo King unit had been on for one hour (60 minutes) the temperature inside the bus was cooled to **29 °C** (From 52°C to 29 °C). This is a reduction of 23°C. (**Refer to Graphic 2.6**).

Once the Thermo King unit started it took **only 33 minutes** to bring the temperature down to 29 °C. This is **27 minutes less** time than the uncoated bus. By the end of the hour the Thermo King Unit brought down the inside temperature to 24 °C. **5 °C** cooler than the bus without SUPER THERM®. (**Refer to Graphic 2.6**)

7. The Thermo King unit coated with SUPER THERM® became 30.5% more efficient.
