RUST GRIP VERIFICATION OF IN-FIELD PERFORMANCE Society of Petroleum Engineers 8 YEAR STUDY UPDATE 2021

8 year Oil field Drill string corrosion testing Program. RUST GRIP introduced into the study in year 6 as a new technology coating for exterior use.

No Pipe Body Downgrades - Improved Corrosion Mitigation Coating System Provides Significant Operator Savings

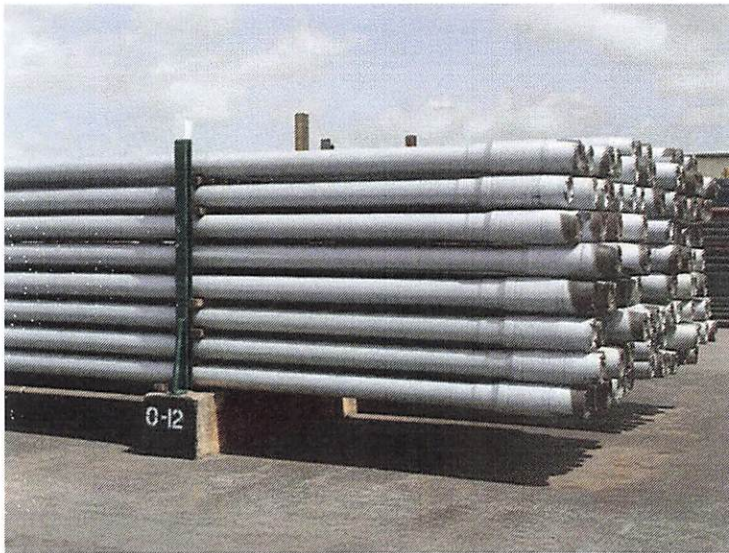
Coated 7-5/8" MaXit807 Completion Landing String

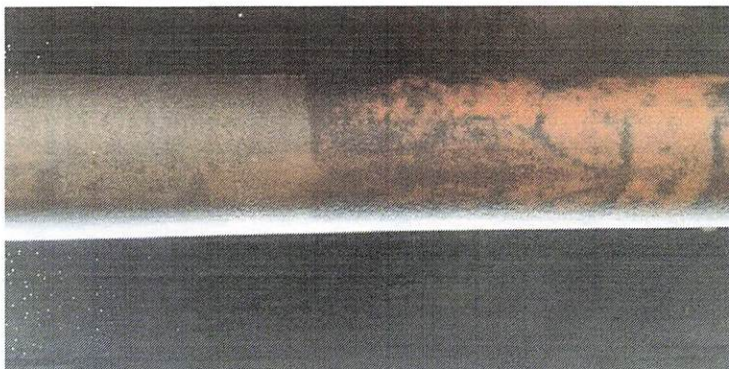
Rust Grip®

vs.

Uncoated

Pipe shown above returned from a completion well project

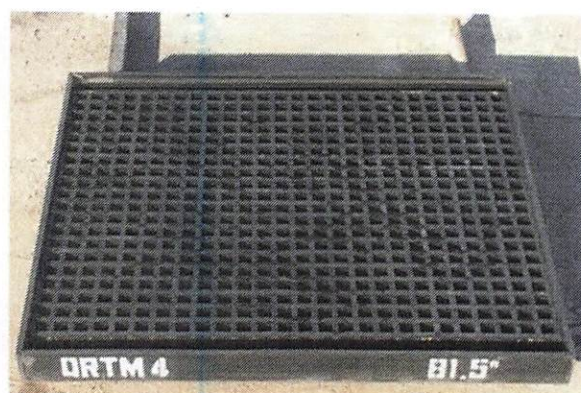
Figure 2—High-pressure pipe washing wand to rinse salt-based fluids from tubulars with optimum jet design and flowrate, and racking mats to facilitate drainage of completion fluids away from connections in order to mitigate corrosion and pitting.

In 2009, further research began on salt neutralization products and cleaning systems to improve corrosion inhibition. New chemical products were introduced for trial in the cleaning system and showed meaningful improvement. Rig crews were also trained and instructed to use new procedures and best practices. New recommended best practices included washing the pipe outer diameter with the newly designed wash wand for improved coverage and flowrate every trip out of the hole during completion operations; washing, drying, and applying fresh thread compound to the connections; using a racking mat; and using multiple wiper rubbers. Rig site training was done where possible. See Figure 2.

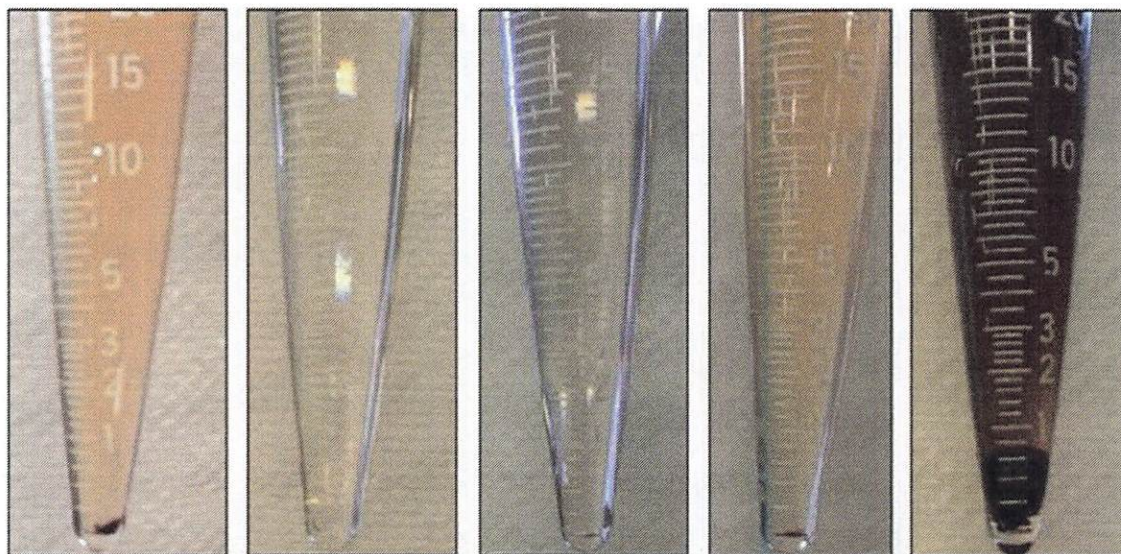
Figure 3—Four coating samples tested on pipe samples immersed in 14.2 ppg CaBr_2 fluid for 12 days against uncoated pipe sample on the right.

The four selected products then underwent a test in completion fluid to monitor the iron-oxide solids produced after an extended time exposed to completion fluid. All four pipe samples with each a different coating product produced very few solids compared to the uncoated pipe sample with a 75-100% reduction in solids compared to the uncoated sample. This testing was done to have a general understanding of the relative difference of a coated surface to an uncoated surface in completion fluid. The measurements were not as important as the scale of difference. The fluids from the coated samples were clear to slightly tinted where the uncoated sample fluid was visibly red/dark due to the iron oxide products, see Figure 3.

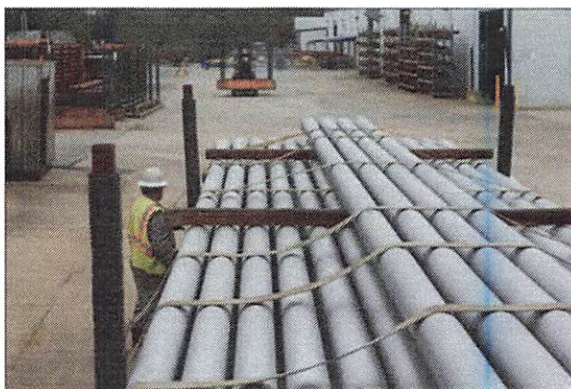
Figure 4—Coated pipe prior to shipment to the rig.

In November 2015, approximately 27,000 ft. of 5-7/8 in. completion pipe coated with the selected coating system, including external coating EC8, was deployed to the Gulf of Mexico for Operator 1. See Figure 4.

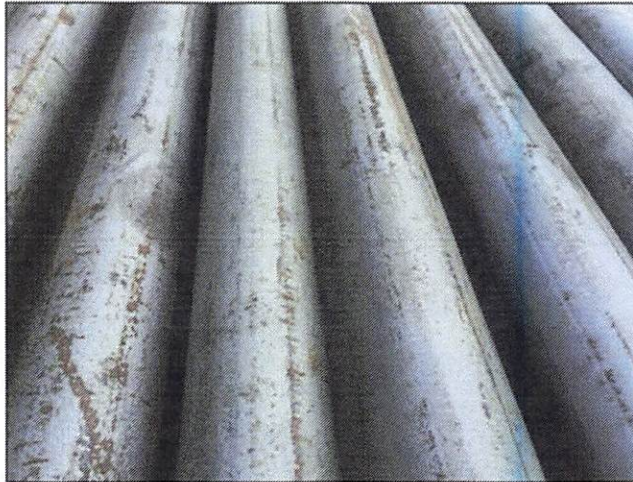
Figure 9—Pipe as returned from open water trial.

In 2015, open water intervention projects were becoming more frequent and the first uncoated intervention risers were damaged by extensive pitting that required the operator to purchase the pipe. Several open water fields trials were conducted to evaluate the selected coating system, EC8, under intervention riser application conditions. See Figure 9. These are summarized in Table 4 below.

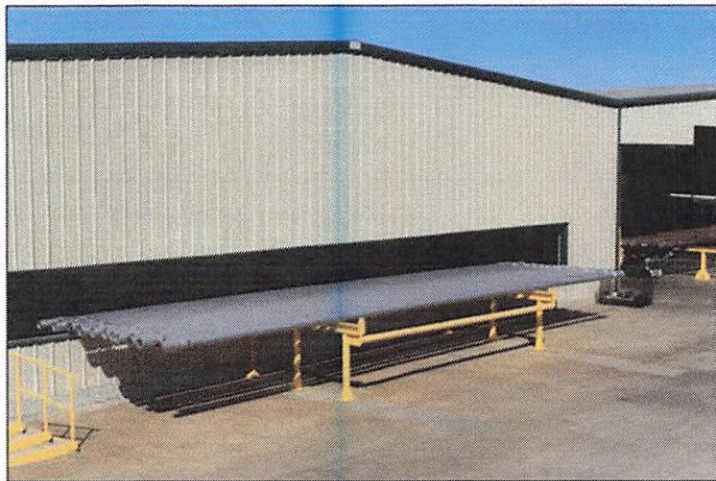
Figure 10—Airless coating application and coating facility.

Crucial to the application process is surface preparation, and the ability to automate, ensuring an even coverage by regulating spray volume, travel of the sprayer, and rotation of the tubulars throughout application. The inability to automate can result in coating build up that can affect tubular handling. Or, lack of automation may result in missed coverage, leaving metal exposed. A dedicated coating facility was completed in late 2014 with the capacity to coat 150 joints per day. A quality control process was developed to ensure consistent coating thickness and dry times. See Figure 10 and 11.

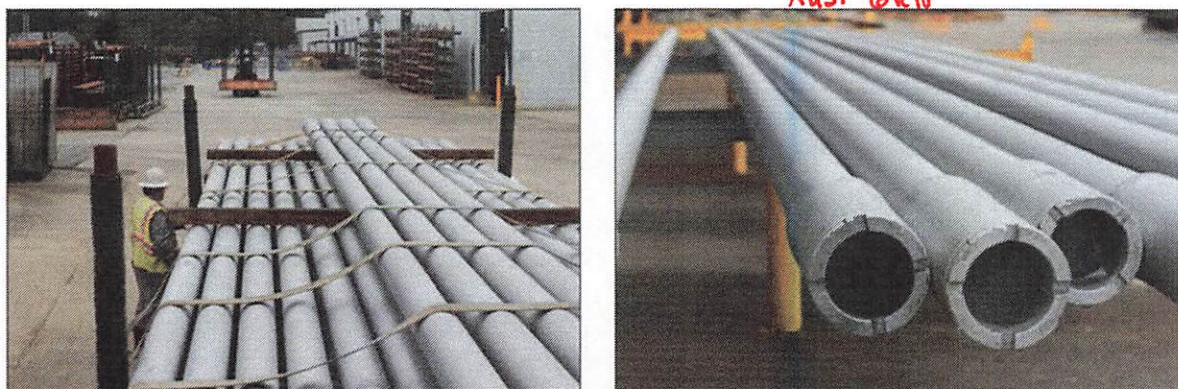
Figure 11—Pipe ready for deployment.
